A TOTAL QUALITY APPROACH TO PAVEMENT SPECIFICATION

John Knapton
Professor of Structural Engineering
University of Newcastle upon Tyne
UK

ABSTRACT

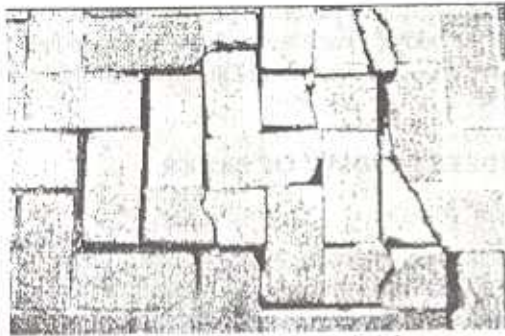
Figure 1 shows the way in which areas of rigidly set brick pavers gradually deteriorated in this bus station. The cement mortar bedding material failed to take into account the Environmental and Traffic Issues. There are many instances where similar failures have occurred and the Authors have found that rigidly bedded pavers cannot sustain heavy channelised traffic, particularly at bus stops.

Figure 1. Failure of rigidly set brick pavers at Bellevue Metro, Washington State, US

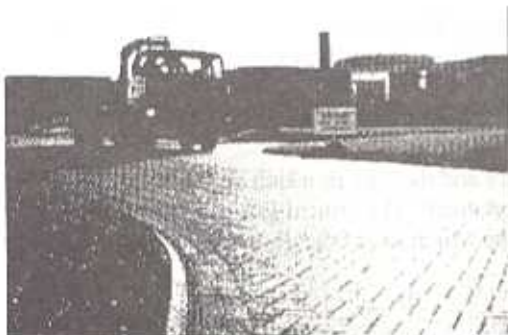
Figure 2 shows the condition of the road after 5,000,000 csa's. It is the access road to a brick manufacturer and is trafficked by heavy vehicles delivering the firm's products. It is important in that it is an early example of a paver road having regular heavy vehicles in an industrial context. The road remains serviceable as a result of its reinforced concrete base and the use of bedding and jointing sands which would fall into Category 2¹⁰.

Figure 2. Heavily trafficked industrial road in Telford, UK.

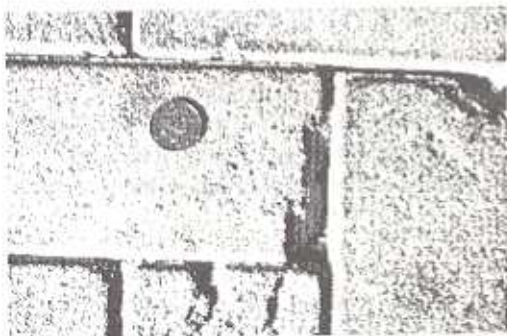
The area comprises an airport vehicle service and parking area. Figure 3 shows how many of the pavers spalled as a result of the rectangular units having no spacers and being installed in a tightly packed manner. The problem was exacerbated by the absence of an adequate base. The problem would have been largely resolved by ensuring that jointing material was present and would have been fully resolved by so doing and providing a more rigid base. The design method for industrial pavements surfaced with pavers was developed at Newcastle University⁷, initially as a Science Research Council project, then as a British Ports Authority contract and finally as a design method sponsored by British Precast Concrete Federation.

Figure 3. Spalled pavers at Bahrain Airport maintenance area.

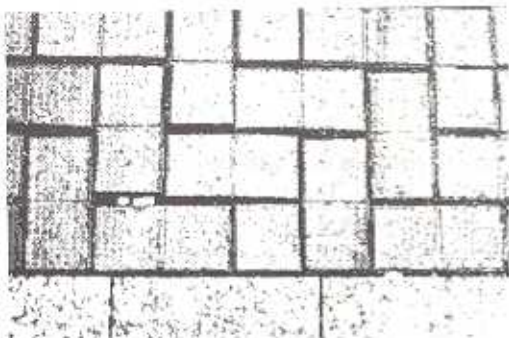
Figure 4 shows the condition of pavers installed in a city centre street after very little use. The pavers had been deliberately spaced to fit into previously constructed surrounds. This led to loss of interlock. Effectively, this is the opposite problem to the one described in Case Study 3. Together, they point to the importance of installing the pavers "hand tight" so that the joint remains filled and generates interlock¹¹.

Figure 4. Jointing material has been lost from pavers at Leeds resulting in loss of interlock.

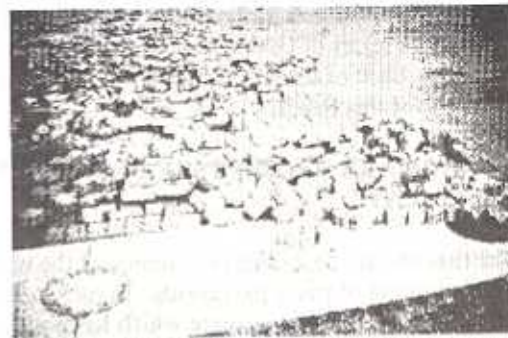
Figure 5. Jet blast has removed pavers from the Eastern Turning Circle at Luton Airport.

Figure 5 shows pavers removed from the Eastern Turning Circle at Luton Airport which occurred on a number of occasions, culminating in a significant failure which damaged an aircraft. A court hearing failed to establish the cause with any degree of certainty but adequate maintenance, drainage of the bedding material and loss of jointing material in an area subject to regular jet blast were all points of discussion (one of the Authors represented one of the parties to the ensuing litigation). Other factors which may have contributed to the difficulties include the use of machines to install clusters and the need to undertake the work through the night with a morning deadline when the runway was back in service. Much of the development of the technology of pavers for aircraft pavements took place collaboratively by Luton Airport and Newcastle University. The work has been published by the Civil Aviation Authority in the UK³ and by the Interlocking Concrete Pavement Institute, with the approval of the Federal Aviation Administration, in the US¹².

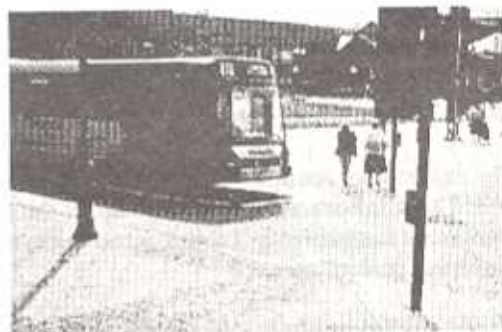
Figure 6. Victoria Road, Hartlepool, UK, showing high quality pavers on steel fibre reinforced concrete base.

Figure 6 shows this heavily trafficked town centre street was constructed in 1993 and has withstood 7,000,000 csa's with no problems. This is as a result of the use of an enhanced specification sand and with the paver joints including a polymer stabilizer. The base comprised steel fibre reinforced concrete installed by a laser guided screeding machine to ensure accurate levels and therefore a consistently thick bedding layer. Research undertaken at Newcastle University has shown the suitability of steel fibre reinforced concrete for highway pavements¹³.

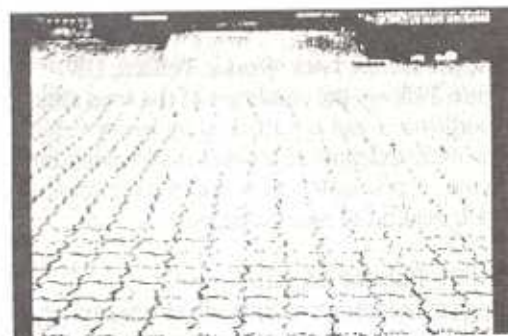
Figure 7. Failure of surfacing on a car park deck as a result of jointing sand being washed/vibrated into bedding course.

Figure 7 shows details of the project in which proprietary shaped pavers were laid by machine over a coarse grit. The fine jointing sand was subsequently washed and/or vibrated into the bedding sand, so leaving the pavers in a non-interlocking state. The laying system whereby 0.5m² clusters were installed without cross linking exacerbated the failure. Also, cluster laid systems develop a wider joint around the perimeter of each cluster, so diminishing interlock. This project highlights the need to ensure compatibility between jointing and bedding materials. It also illustrates that some proprietary shapes can prove more difficult to repair than would simple rectangular pavers.

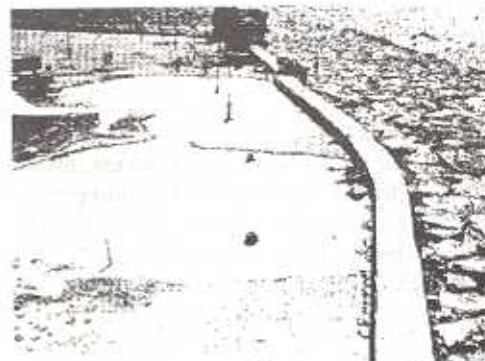
Figure 8. Pavers have been removed from a promenade at Paphos, Cyprus following a severe storm.

Figure 8 show the condition of the promenade following a severe storm which flooded the pavement. Most of the pavers were washed into Paphos Harbour. The area should have been treated with a polymer joint stabilizer but the contractor has not followed the specification. Whether the area would have survived with the joints so treated is not certain, but it would have endured the storm for a prolonged period. Research undertaken at Newcastle University into polymer stabilizers has demonstrated their ability to greatly reduce the permeability of paver joints⁴.

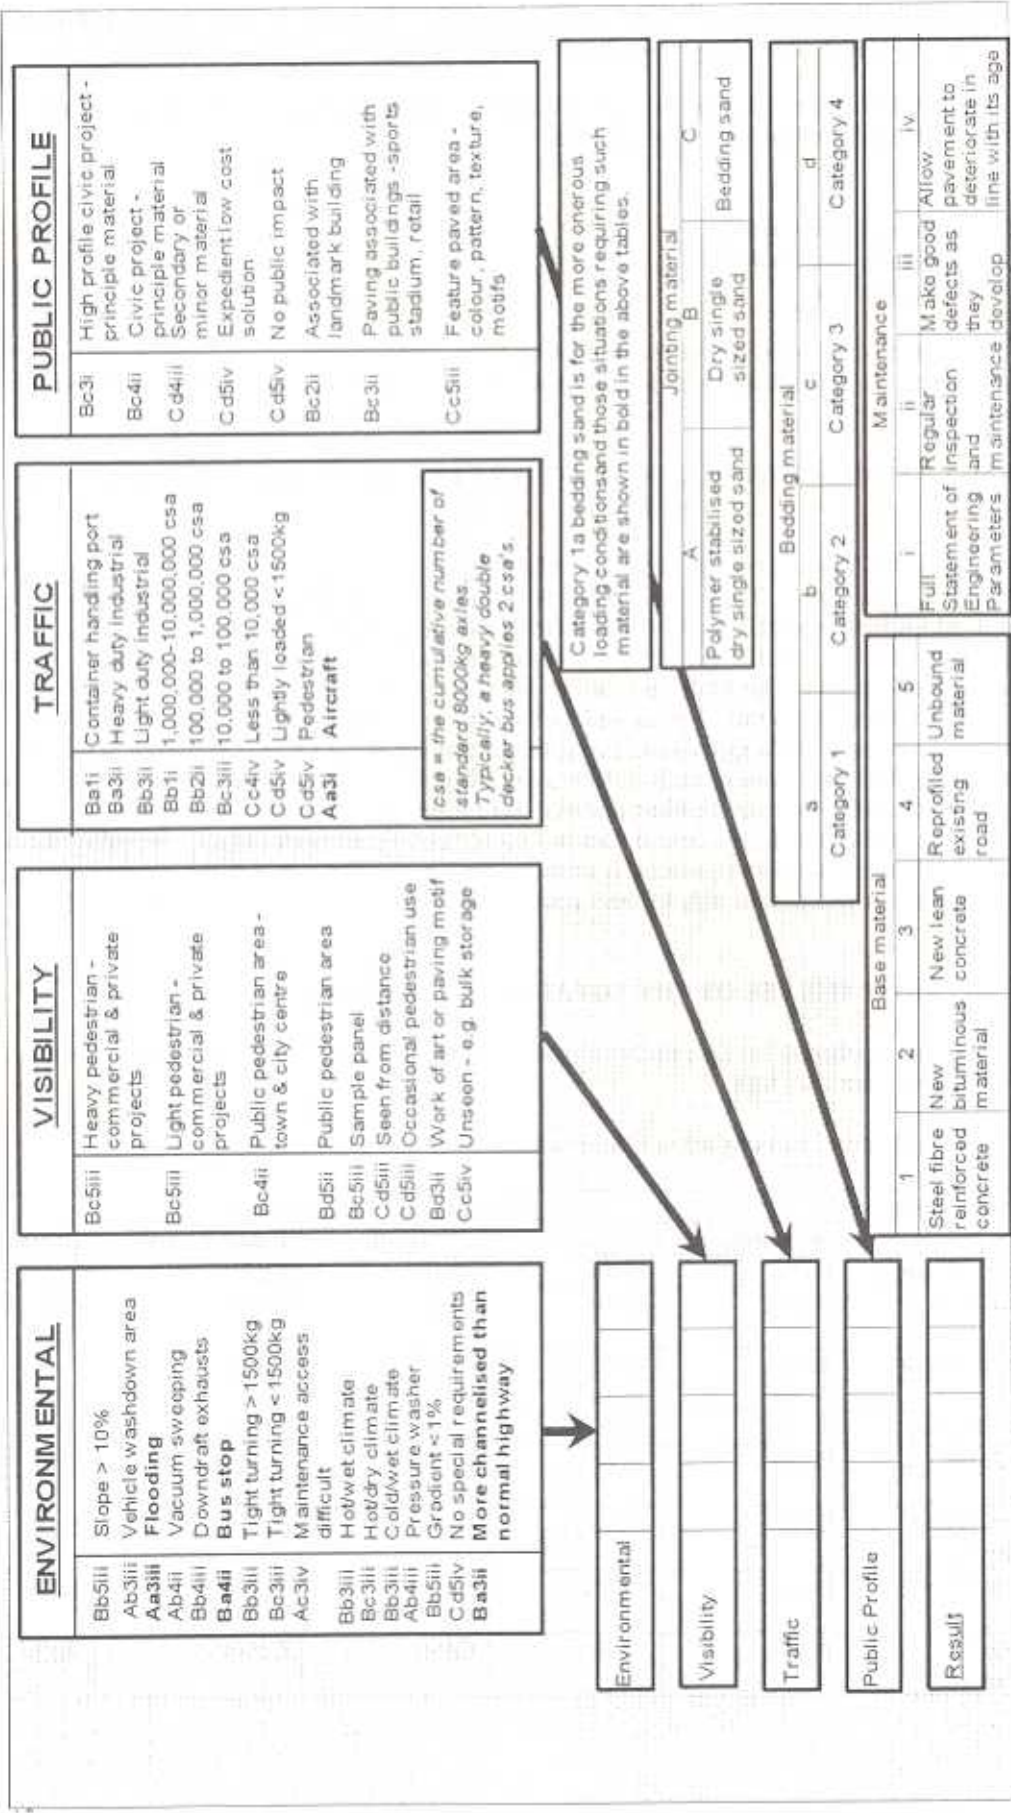
The Total Quality Chart is shown as Fig. 9. Each of the four Issue categories includes a series of factors which fall within that Issue. The user can select those factors which apply to the project in hand. There may be more than one in each Issue box. Each factor has a four element code such as **Bc4ii**. In this code, the upper case letter, **B**, refers to one of three jointing materials. The lower case letter, **c** refers to the category of bedding sand. The Arabic number, **4**, refers to the base material and the Roman numeral, **ii**, refers to the maintenance regime. For each of the four Issues, the user finds the code which is most onerous and transfers it to the appropriate box at the bottom left of the Chart. Once each of the four boxes is filled, the most adverse value of each element is transferred to the Result box. Hence the user can select the appropriate jointing material, bedding material, base material and maintenance regime. These four factors have been shown to be the crucial ones in long term pavement performance. Providing the data upon which the user bases his judgements is accurate, the Chart will ensure that the correct solution is produced. The user will then be able to focus upon developing the requisite specifications in detail.

By comparing the results from Table 2 with the codes which would apply to the case study projects, it becomes clear why some of the projects failed and others succeeded. For example, Bellevue Transit was constructed with inappropriate jointing and bedding material and should have been maintained according to a prescribed Statement of Engineering Parameters. The two projects which have performed well were constructed according to their code. The Bahrain Airport project included inappropriate jointing material and an incorrect base. Pine Street, Seattle had the wrong jointing and bedding material. The Dublin parking deck had the wrong bedding material. Luton Airport and the Paphos Promenade had the wrong jointing and bedding material.
