# A STUDY OF THE PERFORMANCE OF CONCRETE BLOCK PAVEMENTS IN CONTAINER TERMINALS

## Summary

Generally based upon visual inspections only, this paper reviews recent experiences in a number of container terminals around the world where premature fatigue and pavement failures have been experienced where the heavier container handling equipment is used.

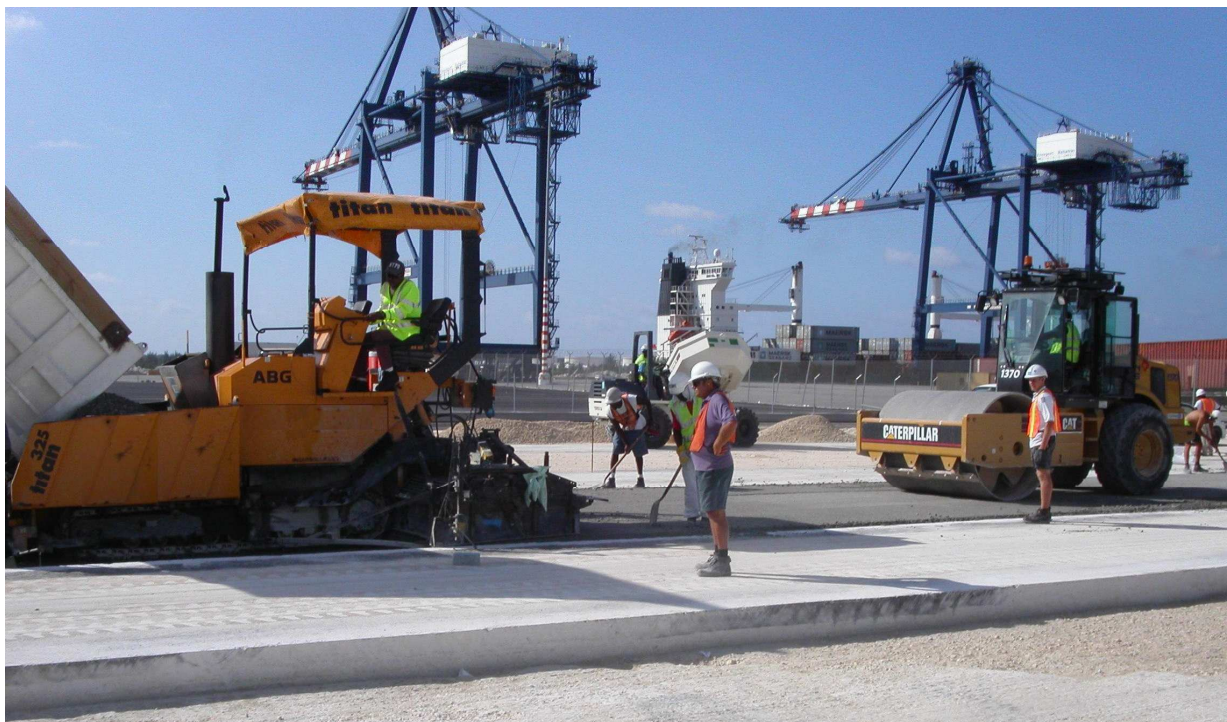
**Figure 1. Cut Back Edges.**

It is important when laying CBM that the edges are cut back to sound fully compacted material as shown in Figure 1.

Unformed joints or joints that display un-compacted material need to be cut back to a clean straight edge to expose adequately compacted material before constructing the adjacent bay of CBM. The minimum cut back of longitudinal and transverse joints shall be to properly compacted material or a width of no less than one layer depth.

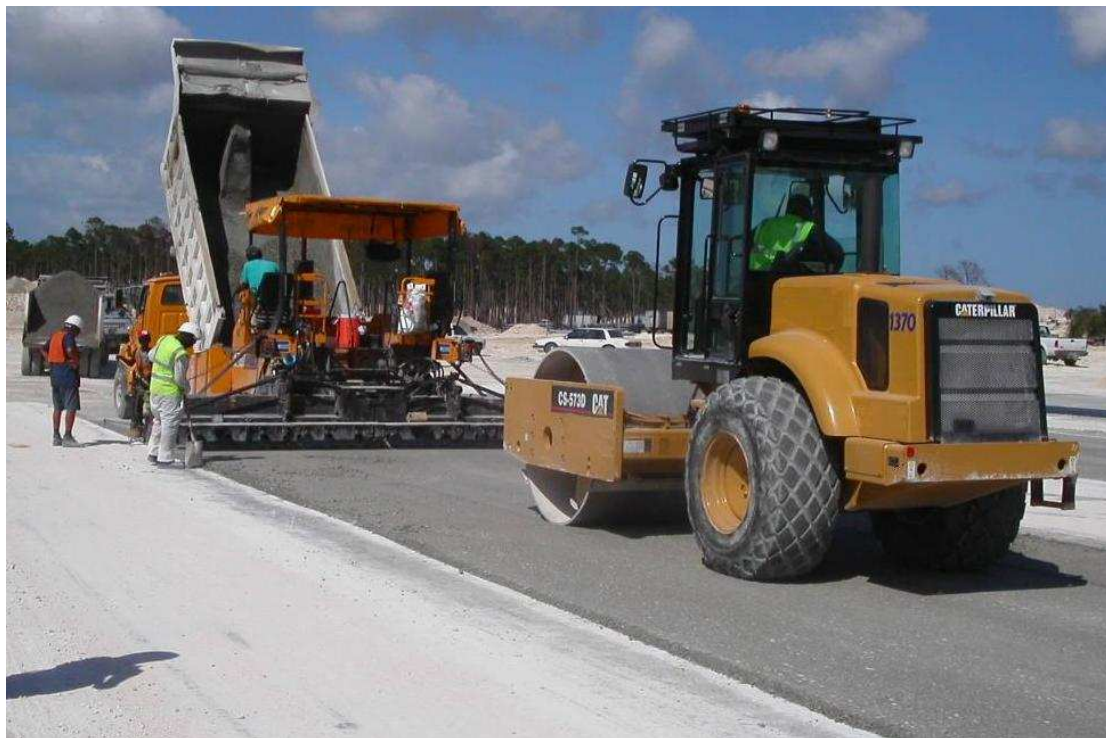
Figure 2. Infilling and compacting using 'hit and miss' method.

CBM base layers can be laid in rips of approximately 3.0 m to 3.5m wide on a “hit and miss” principle whereby alternate rips are placed, compacted and edges cut back. Infill rips are then placed and compacted as shown in Figure 2.

Great care needs to be taken to achieve full compaction of the edges of the CBM rip without causing damage to the CBM in the adjacent bay. It has been observed during the compaction of the edges that the heavy roller overlaps the adjacent top edge on the recently placed CBM layer in the adjacent rip which causes damage to these adjacent top edges.

Extreme care needs to be taken when rolling not to overlap and crush the adjacent top edge. Using wet lean concrete as a base course avoids this potential problem as joints are fully compacted to the surface without any disturbance.

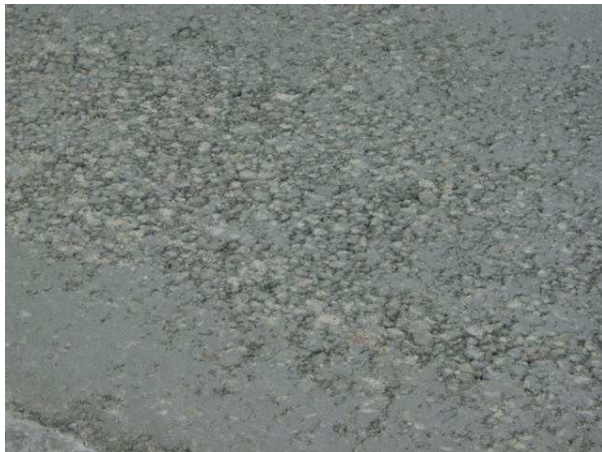
Figure 3. Segregation in finished surface of CBM.

The mix design and placing of the CBM material needs to be closely monitored to ensure that no segregation occurs in the surface of the base course layer as shown in Figure 3, below.

With the passage of heavy wheel loads displacement and crushing of this surface layer will occur under the sand bedding layer ultimately leading to localized failure.

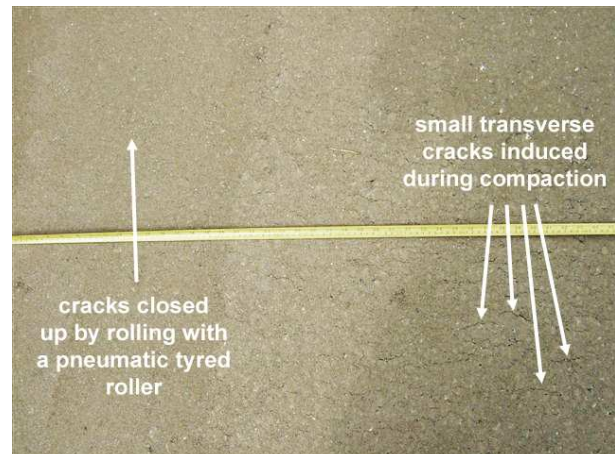
Figure 4. Roller induced cracks.

Sometimes during the compaction process using steel drum vibrating rollers, small transverse cracks and crusting of the surface maybe induce. Before the cement bound material sets, and ideally as soon as possible after the completion of the rolling with steel drum rollers, these cracks can be closed up by using a pneumatic multi-tyred roller (See Figure 4).

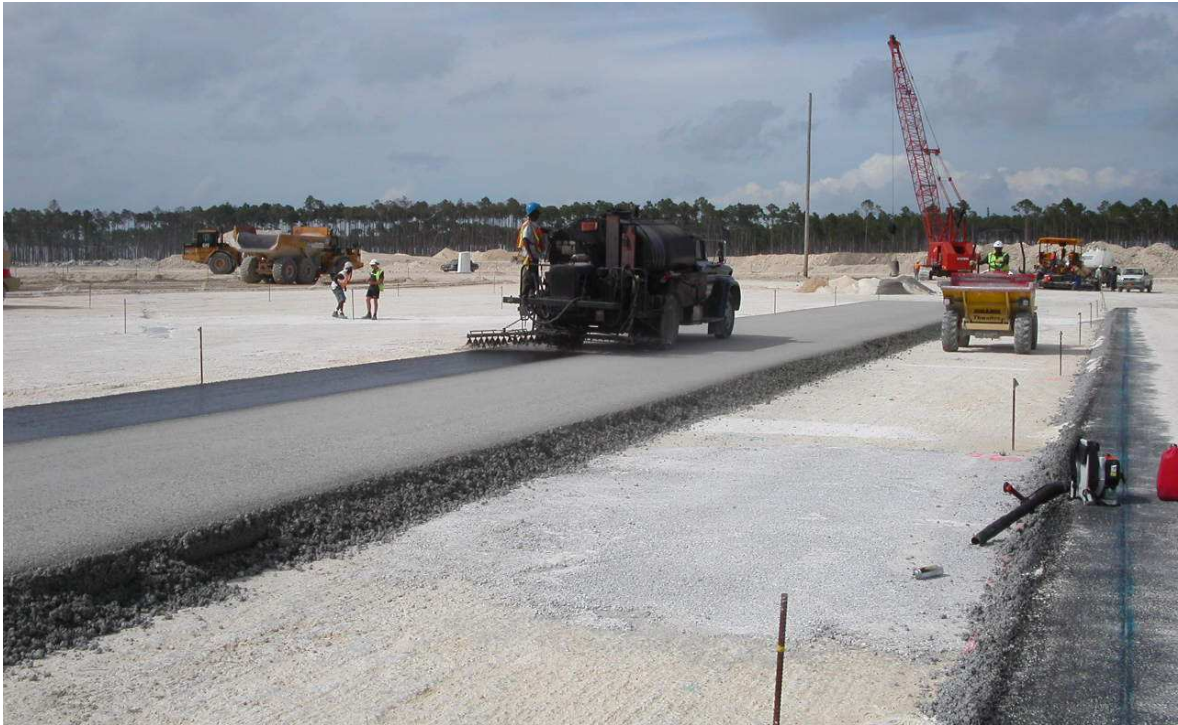
**Figure 5. Application of Bitumen Curing Layer.**

It is important to ensure an even application rate, sufficient only to cure the CBM. Excessive thicknesses of bitumen will lead to contamination of the bedding sand layer and reduce its drainage and load transfer properties. A bitumen sprayer with a calibrated flow meter should be used as shown in Figure 5.

Note that the edges of the CBM have been marked ready for saw cutting.

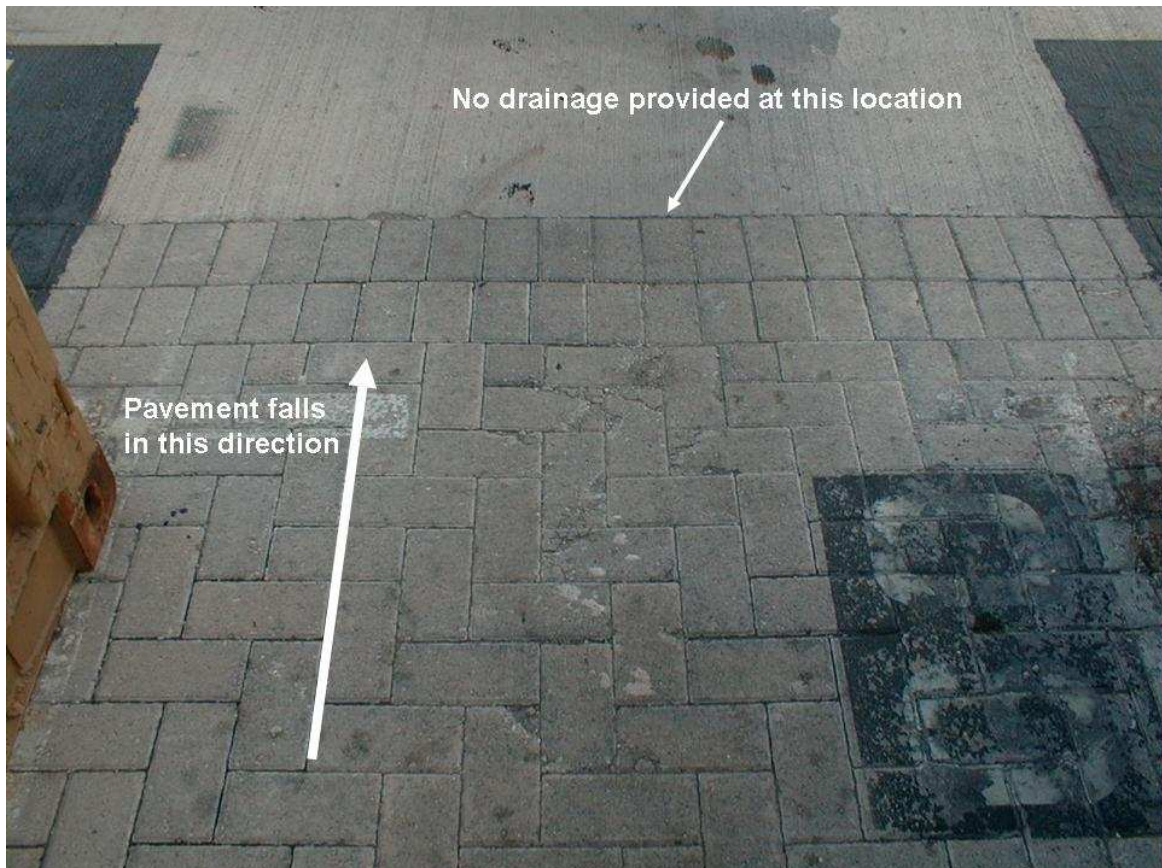
**Plate 6 – Failure at Interface with Edge Restraint.**

This problem is particularly prevalent at the bottom of downhill grades at valleys, or against edge restraints where free water will stand if not drained away quickly. A typical failure is shown in Figure 6, below.

A method that has been used in the past is a “drainage hole” method. A line of 50mm diameter vertical drainage holes at the underside of the sand bedding layer is drilled through the CBM base course into a no-fines concrete under-drain. A disadvantage of this method is that it may create a potential weakness in the pavement.

Drainage of the sand bedding can be achieved by drilling or forming holes, 30mm diameter, to drain the bedding sand directly into drainage channels or drainage pits. Typically these holes would be at 1.0 m centres or at the four (4) sides of a drainage pit [Howe, 1993].

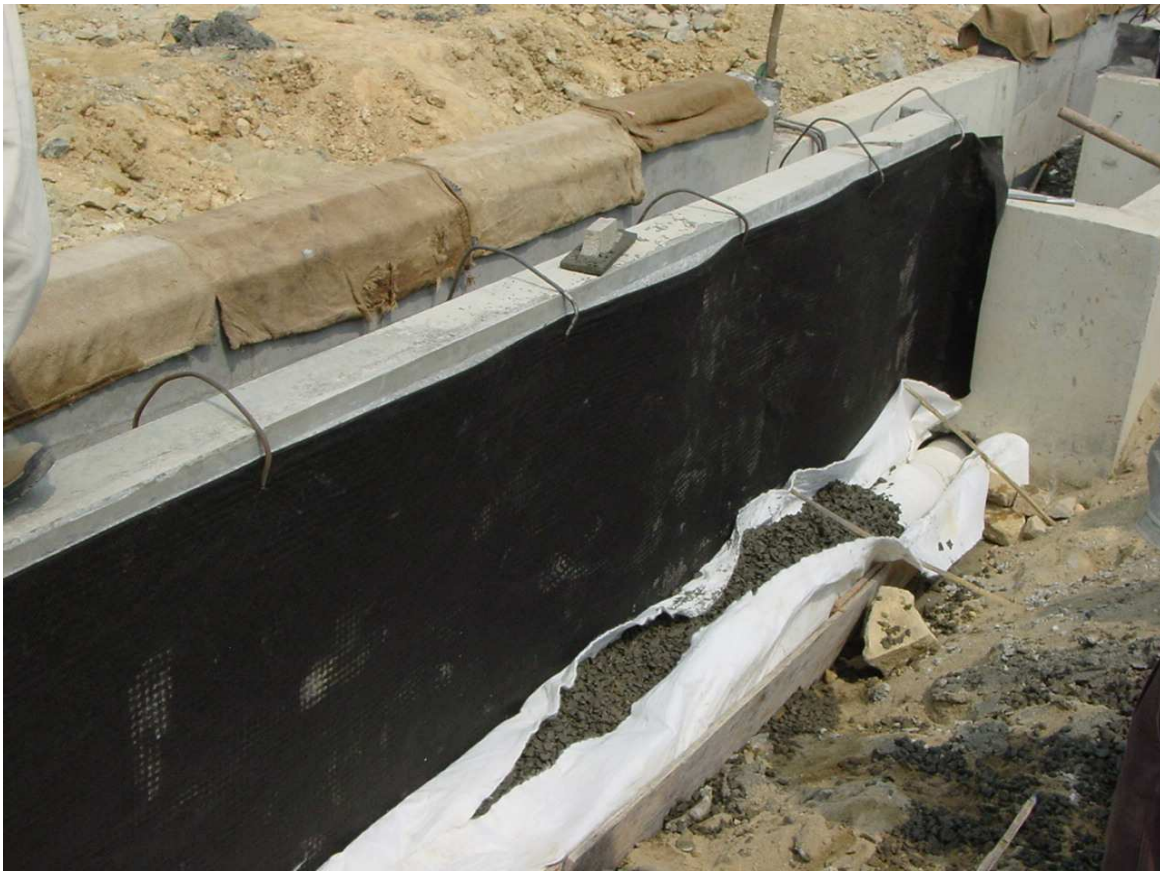
**Figure 7. Bedding layer drainage detail.**

A more sophisticated method was developed in the mid 90’s incorporating a prefabricated drainage composite geotextile drain placed vertically against the edge structure and connected to under drainage providing a much more positive drainage path. This is shown in Figure 7.

6. Drainage of the sand bedding layer into the permanent drainage system is essential. Particular attention needs to be given to provide adequate drainage of the bedding sand without inducing structural weaknesses in the pavement.
