10th International Conference on Concrete Block Paving
Shanghai, Peoples Republic of China, November 24-26, 2012

Potential Application of ASTM C 1701 for Evaluating Surface Infiltration of Permeable Interlocking Concrete Pavements

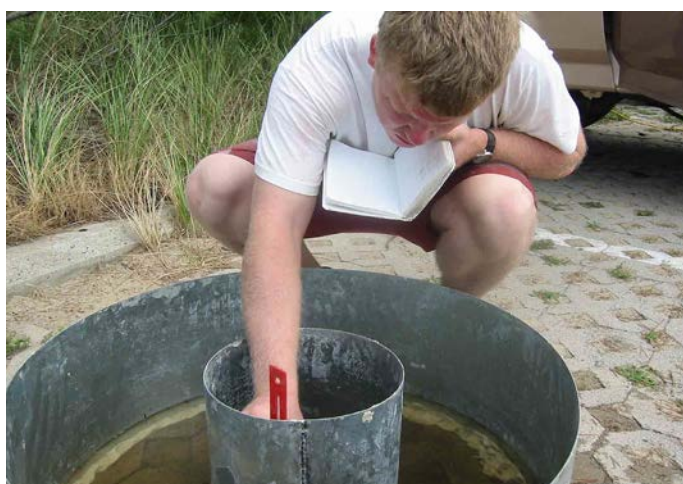
Figure 1. Double ring surface infiltration device used by Bean in 2004.

Initially approved by ASTM in 1975, ASTM D 3385 *Standard Test Method for Infiltration Rate of Soils in Field Using Double-Ring Infiltrometer* is a test method for assessing soil infiltration rates between 10^{-4} and 10^{-8} m/sec. In 2004, ASTM D 3385 was tried by Bean (Bean 2007) while evaluating surface infiltration of PICP, concrete grid and pervious concrete pavement sites in North Carolina, Virginia, Maryland, and Delaware. Figure 1 shows the double ring infiltration testing device. He moved to a single ring infiltrometer due to high surface infiltration rates of the permeable pavements tested and the volume of water required for maintaining hydraulic heads within the rings.

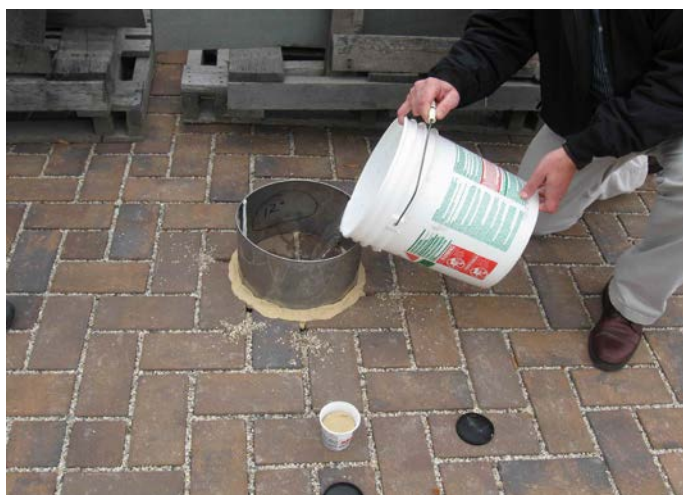
Figure 2. ASTM C1701 test apparatus at a building supply store parking lot

The design storm required for infiltration by the local municipality is equivalent to a storage volume of 40 mm in a 24-hour period or a 90% rainfall event as defined by the New York State Stormwater Management Design Manual. Figure 2 illustrates the test site with the ASTM C1701 test apparatus.

Both test locations in Lindenhurst used plumber’s putty to seal the metal ring against the pavers as shown in Figure 2. On both sites, the jointing stones are removed between the joints under the ring and filled with plumbers putty to further direct the water downward. Removal of the jointing stones can be done with a putty knife and screwdriver. A key consideration on locating the ring is to frame the paver joint pattern within the ring. This framed area should represent the percentage of open area in the overall surface to best characterize surface infiltration. Besides characterizing the overall permeable jointing pattern, this location can reduce the time and effort required to remove jointing stones and filling the joints with plumber’s putty.

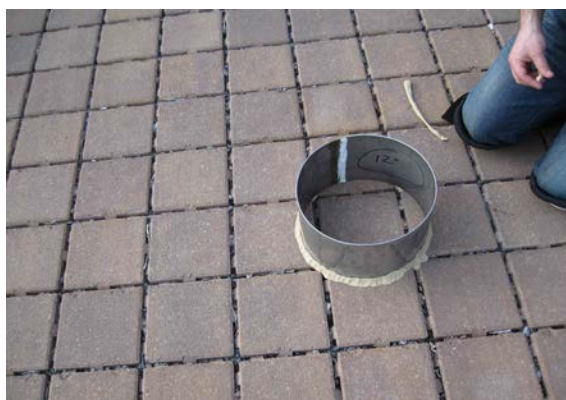
Figure 3. ASTM C1701 test apparatus at a public library parking lot

Another test using ASTM C1701 was conducted at a 600 m² PICP parking lot at a public library in Lindenhurst, New York. The paving units were 200 x 200 x 80 mm thick with 13 mm wide joints filled with ASTM No. 8 stone. The paving units and jointing material were installed over 40 mm thick ASTM No. 8 bedding stone. This was placed over a 100 mm thick ASTM No. 57 base and a 150 mm thick subbase of ASTM No. 3 stone over a highly permeable soil subgrade. Figure 3 illustrates the test site with the ASTM C1701 test apparatus.

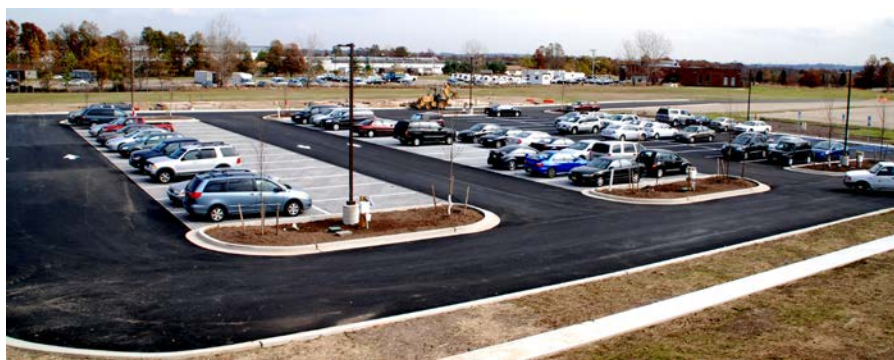
Figure 4. Pervious concrete (light colored parking area on left), PICP (center) and porous asphalt (right) at a test facility at US EPA laboratories in Edison, New Jersey

In fall of 2009, the US Environmental Protection Agency opened a 110-car parking lot for staff at their Edison, New Jersey, National Risk Management Laboratories. The parking lot was designed to evaluate the long-term performance of PICP, pervious concrete and porous asphalt. The parking facility is illustrated in Figure 4 with the three permeable pavement surfaces each approximately 530 m² for car parking. The research objectives and parameters for this multi-year monitoring project are shown in Table 3.

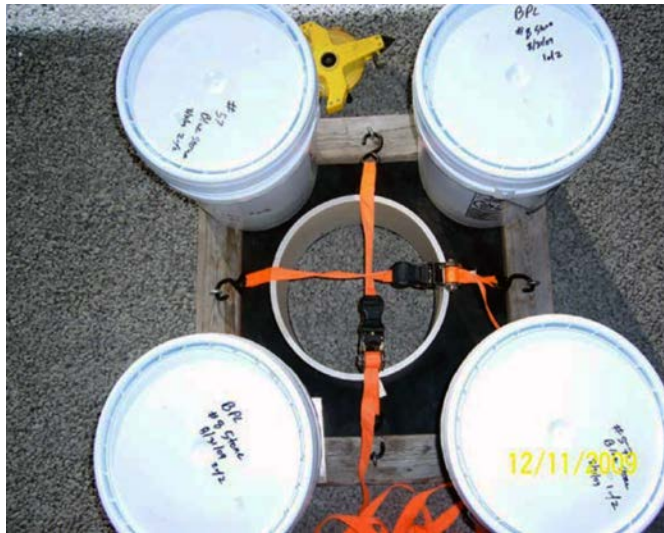
Figure 5. Modified ASTM C1701 using neoprene seal on the porous pavement (Borst 2010)

Instead of using plumber’s putty to create a seal between the ring and the pavement surface, neoprene is used on the ring and it is pressed into the pavement surface with plastic buckets weighted with stones. This accelerates set up, measurements, and clean up. Figure 5 illustrates

the apparatus. All other aspects of the test method appear to be similar to ASTM C1701 (Borst 2010).
